Manhole Inspection Summary

Manhole # S25YY_G02MH

Location Address: **3300 CLIPPER RD** Cross Street: **CLIPPER MILL RD**

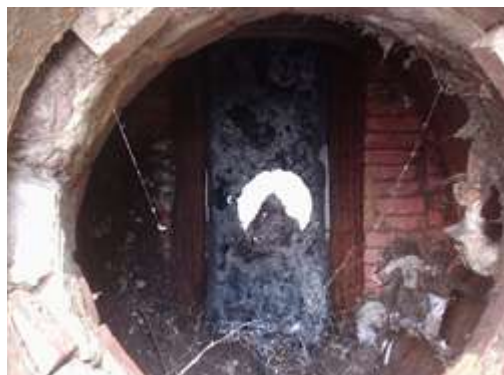
Top View

Corroded steps. Evidence of surcharge - Bench debris. Channel debris.

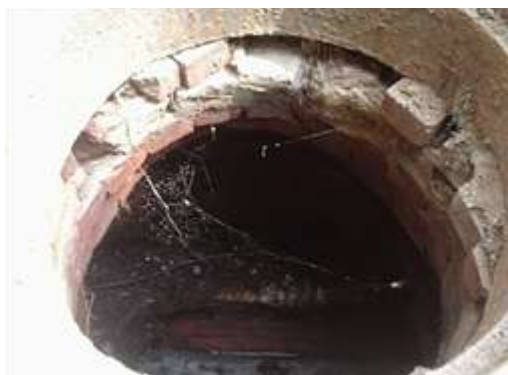
Defect

Frame leaks. Adjustment deterioration, loose brick and infiltration - other side.

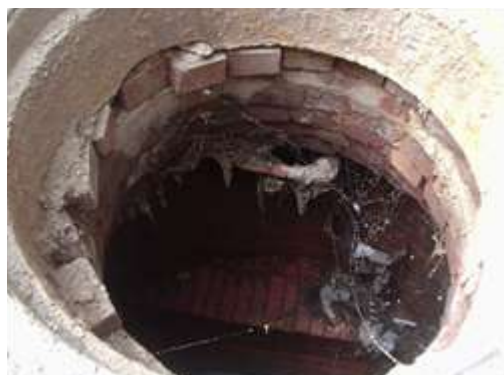
Defect

Frame leaks. Cracked frame. Adjustment deterioration, loose brick and infiltration. Corbel deterioration and infiltration.

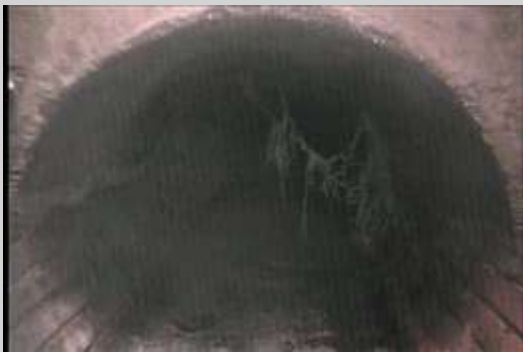
24 in. Circular Gravity Sewer Pipe Out @ 12 O'Clock

Deposits: ☐ None ☒ **Mud** ☐ Sludge ☒ **Debris** ☐ Grease

Silt Depth: **3** (in.) Deposits Extent: **Light**

Infiltration: **Evidence** Pipe Seal Cond: **Unknown**

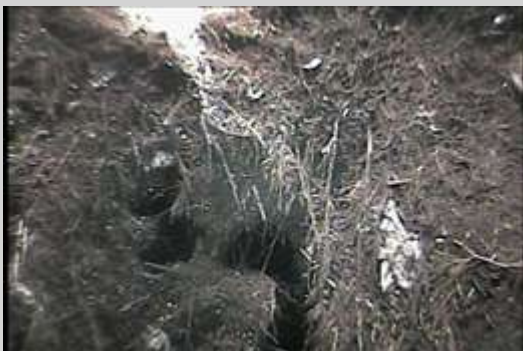
24 in. Circular Gravity Sewer Pipe In @ 6 O'Clock

Barrel root intrusion and infiltration.

Infiltration: **Evidence** Pipe Seal Cond: **Roots**
